Richmond Capitol

Real-time monitoring of the Virginia State Capitol during adjacent deep excavation works

Richmond (VA) - UNITED STATES

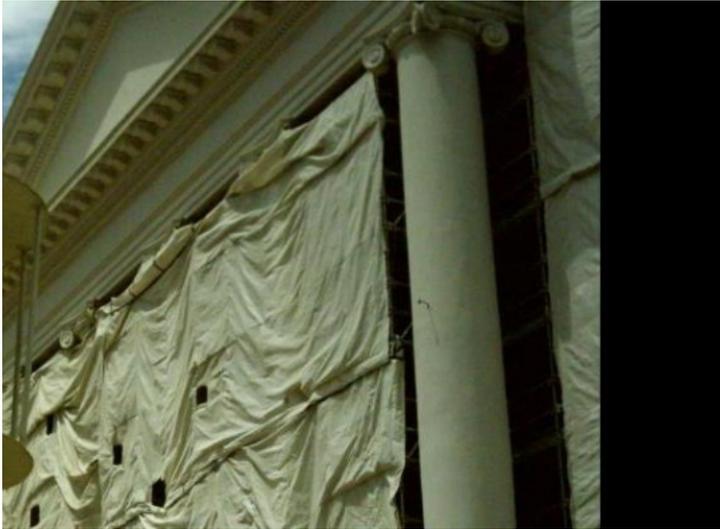
Cyclops monitoring the Capitol

The Virginia State Capitol building was identified as requiring monitoring when a deep excavation immediately adjacent to it was proposed. A real-time instrumentation system was installed, consisting of three SIXENSE Cyclops systems (Automatic Total Stations) with about 80 optical prisms, two in-place and one manual inclinometer and temperature sensors.

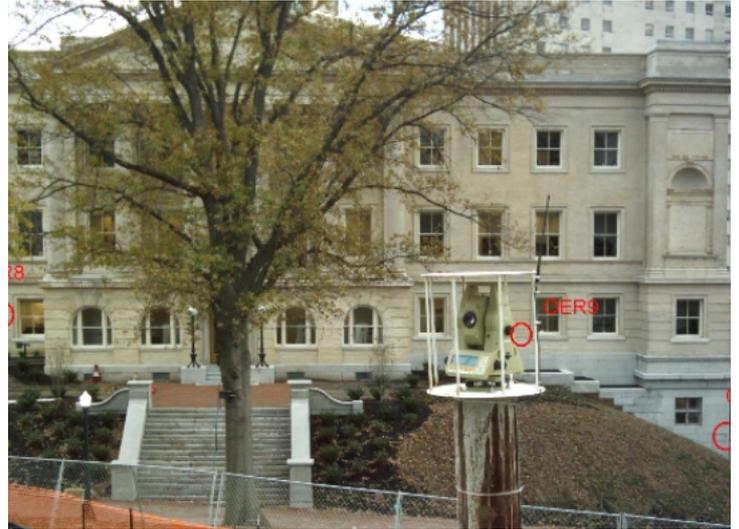
Cyclops setup with background references
