Cherokee and Douglas dams

Deformation monitoring during structural modifications for PMF (Probable Maximum Flood) and Seismic Loadings

Knoxville - UNITED STATES

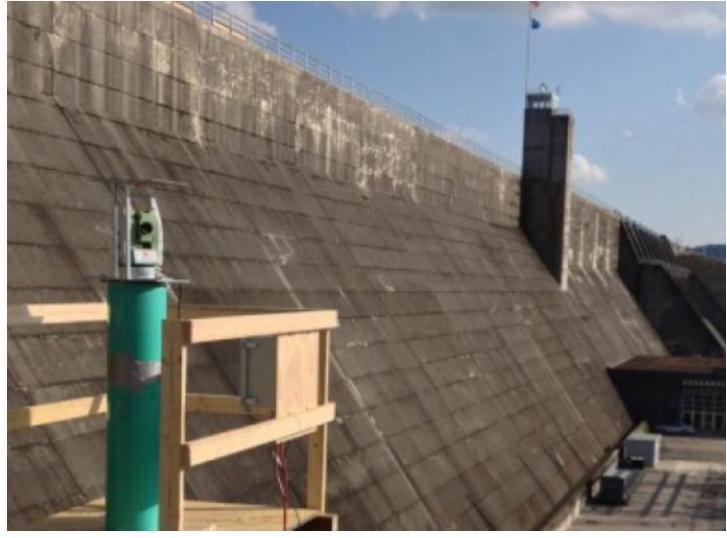
AMTS at Cherokee Non-overflow Zone

The main challenge of the monitoring task was the high precision requirements. At first, a manual survey solution was evaluated. However, an Automated Data Acquisition System (AMTS) was proposed by SIXENSE and accepted by the TVA.

The AMTS system provided a near real time monitoring solution for both dams with accuracy of x,y,z coordinates between 1-3mm within 300'-400' of target prism to AMTS.
